Middle Bear Canyon Erosion Investigation, Catalina Mountains, Tucson Arizona.

Carried out by LTRR students spring semester, 2000.

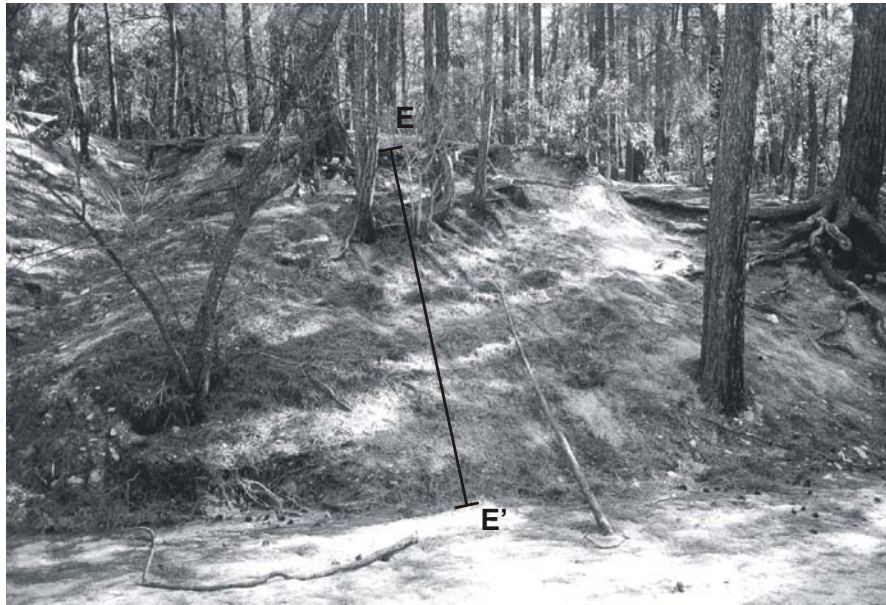
The group of twisted trees near profile "E" probably began growth on the high bank which was undercut and slumped in the 1850s - resulting in the twisted forms as the trees re-oriented to vertical. These trees began growing in the 1830s or 40s (age estimated when correcting for coring height). Tree size and tree age were not well related as these trees proved similar in age to much larger individuals above and below that had not been affected by the bank slump.

Profile "E" with twisted trees on fallen bank section.

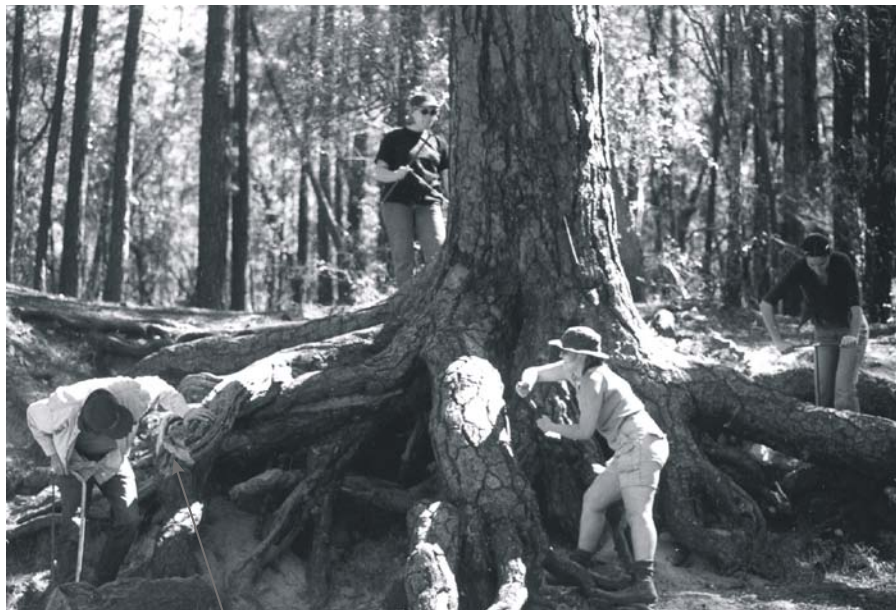
The large tree with the massive expose roots provided evidence of erosion prior to 1850. A large root was wounded on its upper surface by fire in 1819. By 1851 enough erosion had occurred to expose the bottom and it was scarred by a fire in 1851 on its lower surface.

Tree pith >1760

Root, wounded on top: 1819
scarred on bottom: 1851
