## **Middle Bear Canyon Erosion Investigation, Catalina Mountains, Tucson Arizona.**

Carried out by LTRR students spring semester, 2000.

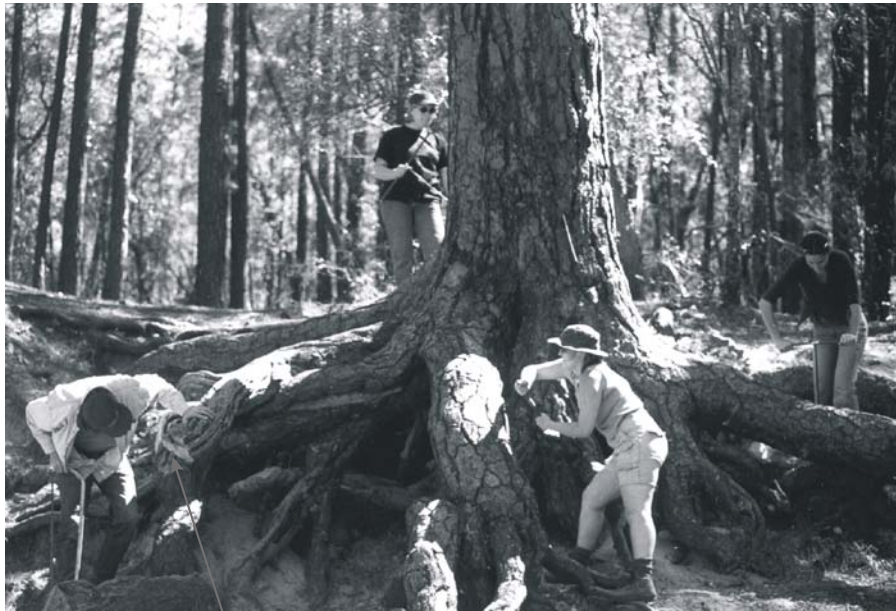
The group of twisted trees near profile "E" probably began growth on the high bank which was undercut and slumped in the 1850s - resulting in the twisted forms as the trees re-oriented to vertical. These trees began growing in the 1830s or 40s (age estimated when correcting for coring height). Tree size and tree age were not well related as these trees proved similar in age to much larger individuals above and below that had not been affected by the bank slump.

Profile "E" with twisted trees on fallen bank section.
