THE CAIRO DAHSHUR BOATS

A Thesis

December 2005

Major Subject: Anthropology

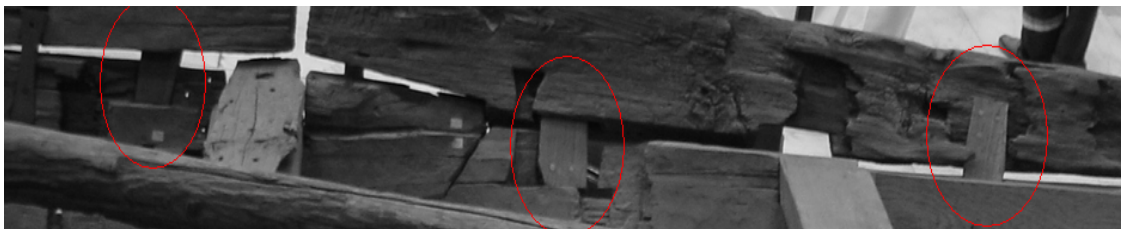
Figure 6. Mortise-and-tenons joining port strakes 4 and 5 on GC 4925 (P. Creasman).

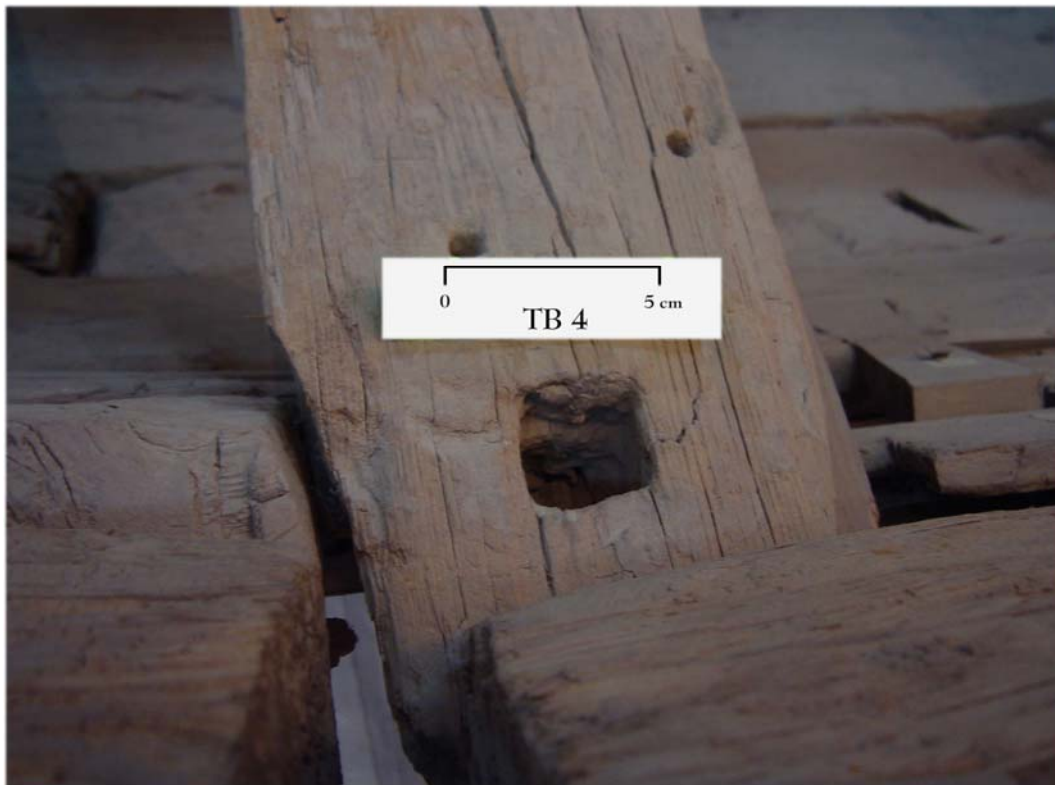
Each throughbeam is spaced approximately 70 cm apart and its ends are flush with the outer surface of the hull. Throughbeam 11 protrudes slightly from the outer surface of the hull but this is due to distortion over time. The wood-grain of all throughbeams runs parallel with the length of the beam.

Figure 24. Starboard end on throughbeam 4 of the de Morgan boat showing narrowing (P. Creasman).

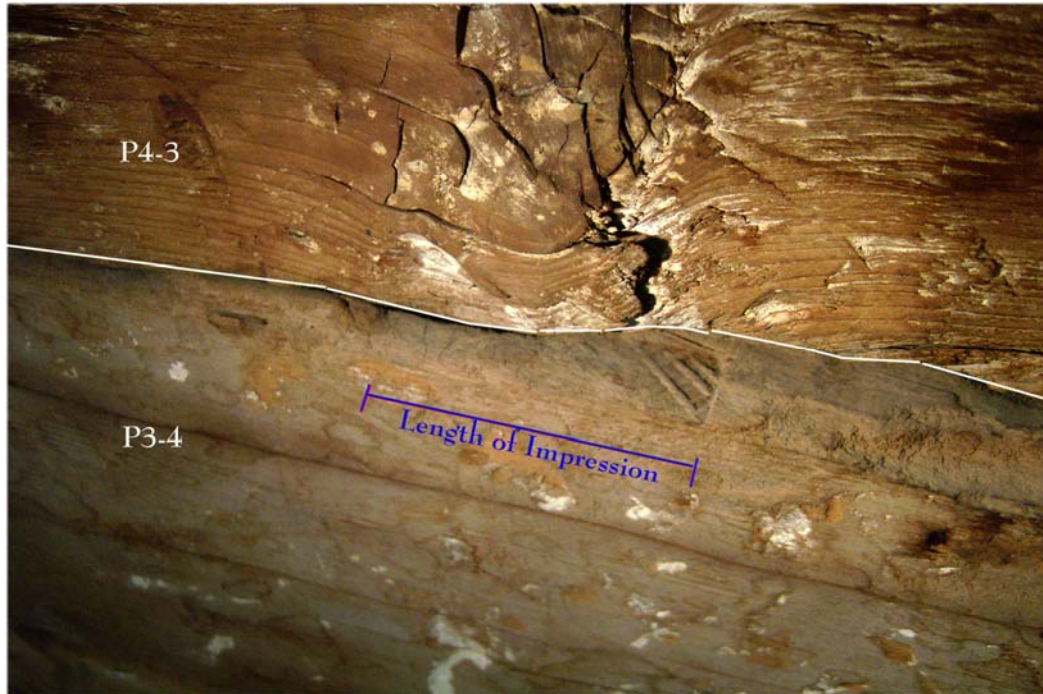
well with the head of the ancient hammer, this pattern is also common on modern clamps that were used when assembling or disassembling the hull.¹²⁸

Figure 28. Close up of a cross-hatched impression at a mortise on the de Morgan boat (J. Levin).

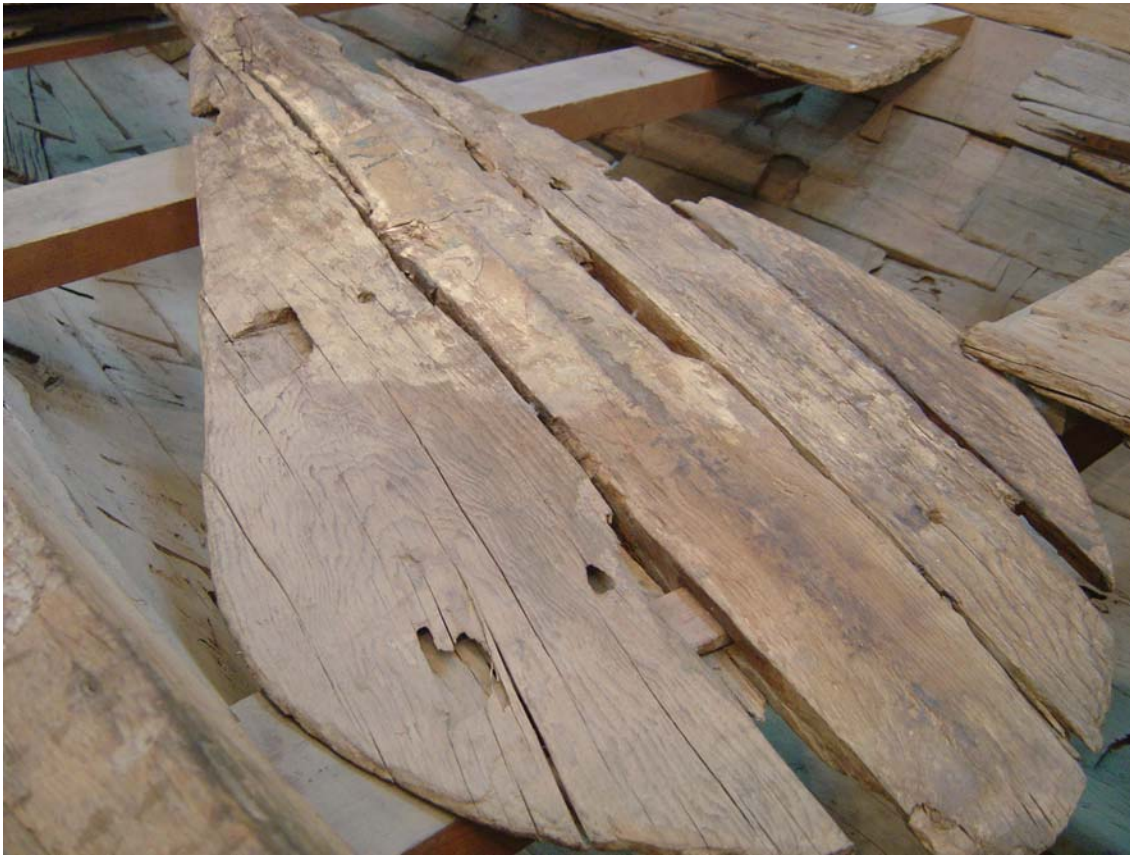
The de Morgan boat has two quarter rudders; that which currently is stored on deck measures 3.6 m long, has a blade length of 1.2 m, and originally consisted of three pieces: a long central piece and two wings affixed on either side (Figure 29). The loom is straight, circular in section, with maximum diameter of 10 cm at midpoint and was shaped from the core of a tree. Approximately one meter from the top of the blade, the loom begins to flatten slightly from its round section. At the point where the loom and blade meet, the section is noticeably more rectangular, ending in a wedge shape at the rounded tip. The blade's wings are fixed to the central loom with at least three pegged mortises and tenons per side, measuring 7.5 cm wide and 1.8 cm thick, with varying lengths. Original paint remains on several pegs indicate that both the pegs and the tenons are original. One wing of the blade has a 2.5 cm x 2.7 cm hole cut through it about 40 cm from the top. A rope would have run through this hole to secure the quarter rudder to the vessel.

Figure 29. Blade of a quarter rudder (J. Levin).

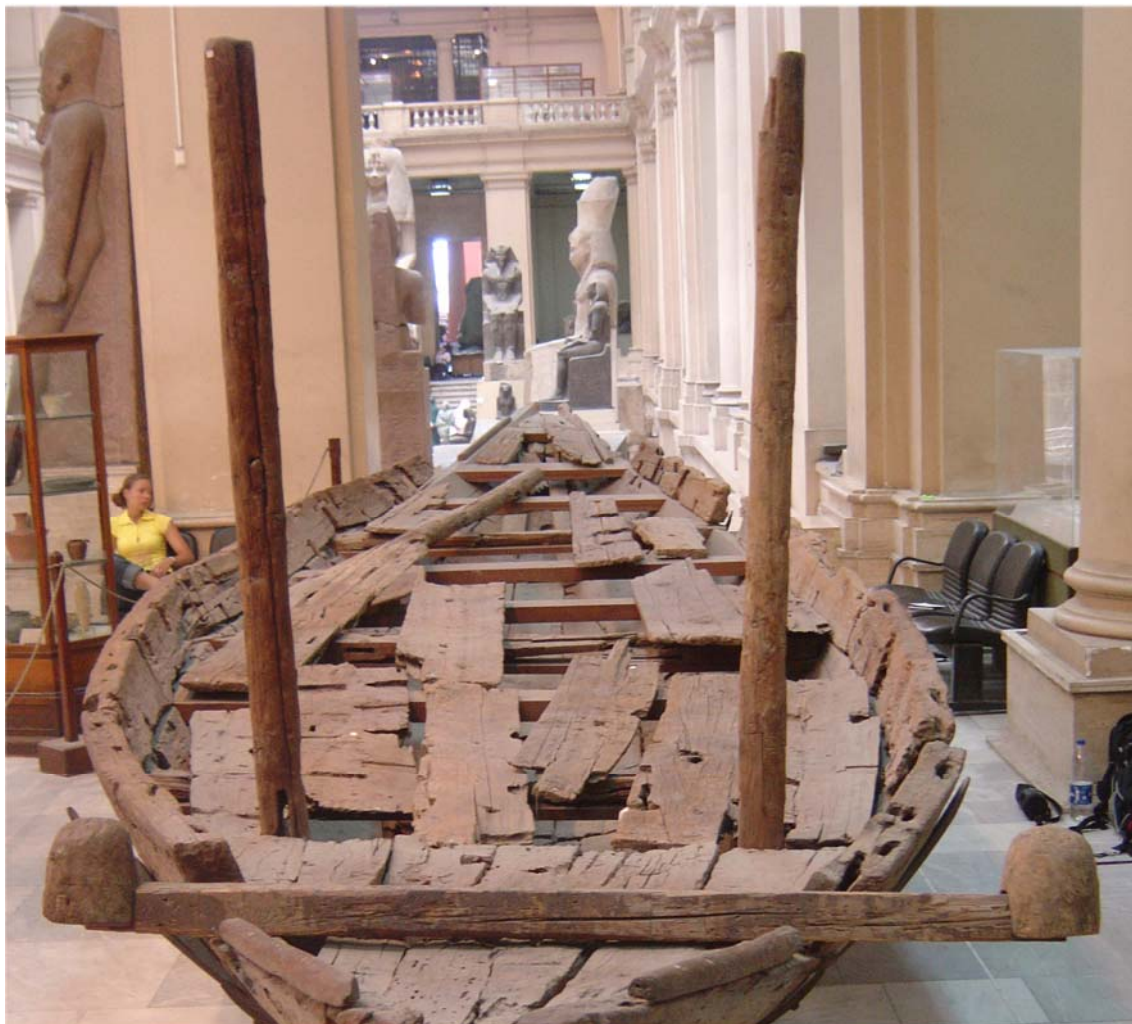
The two quarter rudder stanchions measure 1.71m and 1.70 m in height but both have received modern modification at their tops (Figure 30). At the top they are round in section gradually changing into a square section about 50 cm above where they pass through sockets in throughbeam 10. The diameter of the rounded area is approximately 10 cm and the width of the square area is 12 cm. Both stanchions fit snugly through throughbeam 10 and rest in shallow divots fashioned in the hull plank below.

Figure 30. Stanchions on the de Morgan boat, from stern (P. Creasman).

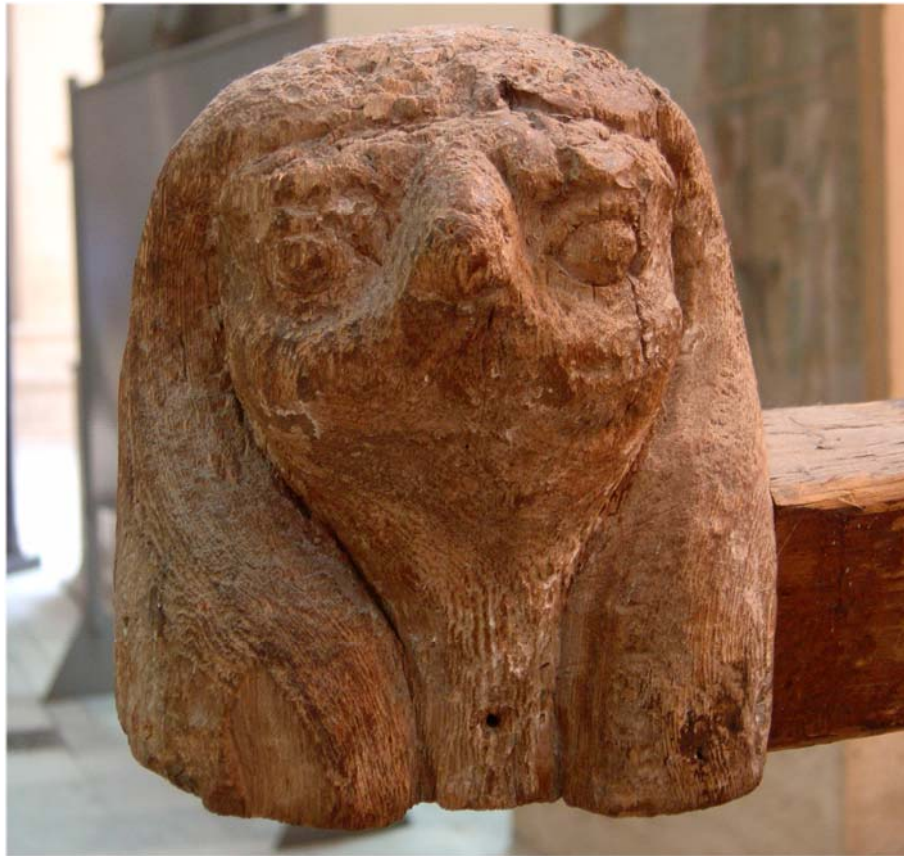
box that contains four more Horus-head carvings from the de Morgan boat.¹³¹ The total number of carvings found on this boat, therefore, is six—one on top of each quarter rudder, one on top of each stanchion, and one on each end of the crosspiece. There may be additional Horus-head carvings that went on the ends of an upper crosspiece, but this is currently unconfirmed.

Figure 31. A Horus-head carving mounted on the starboard side of the quarter rudder crosspiece (P. Creasman).

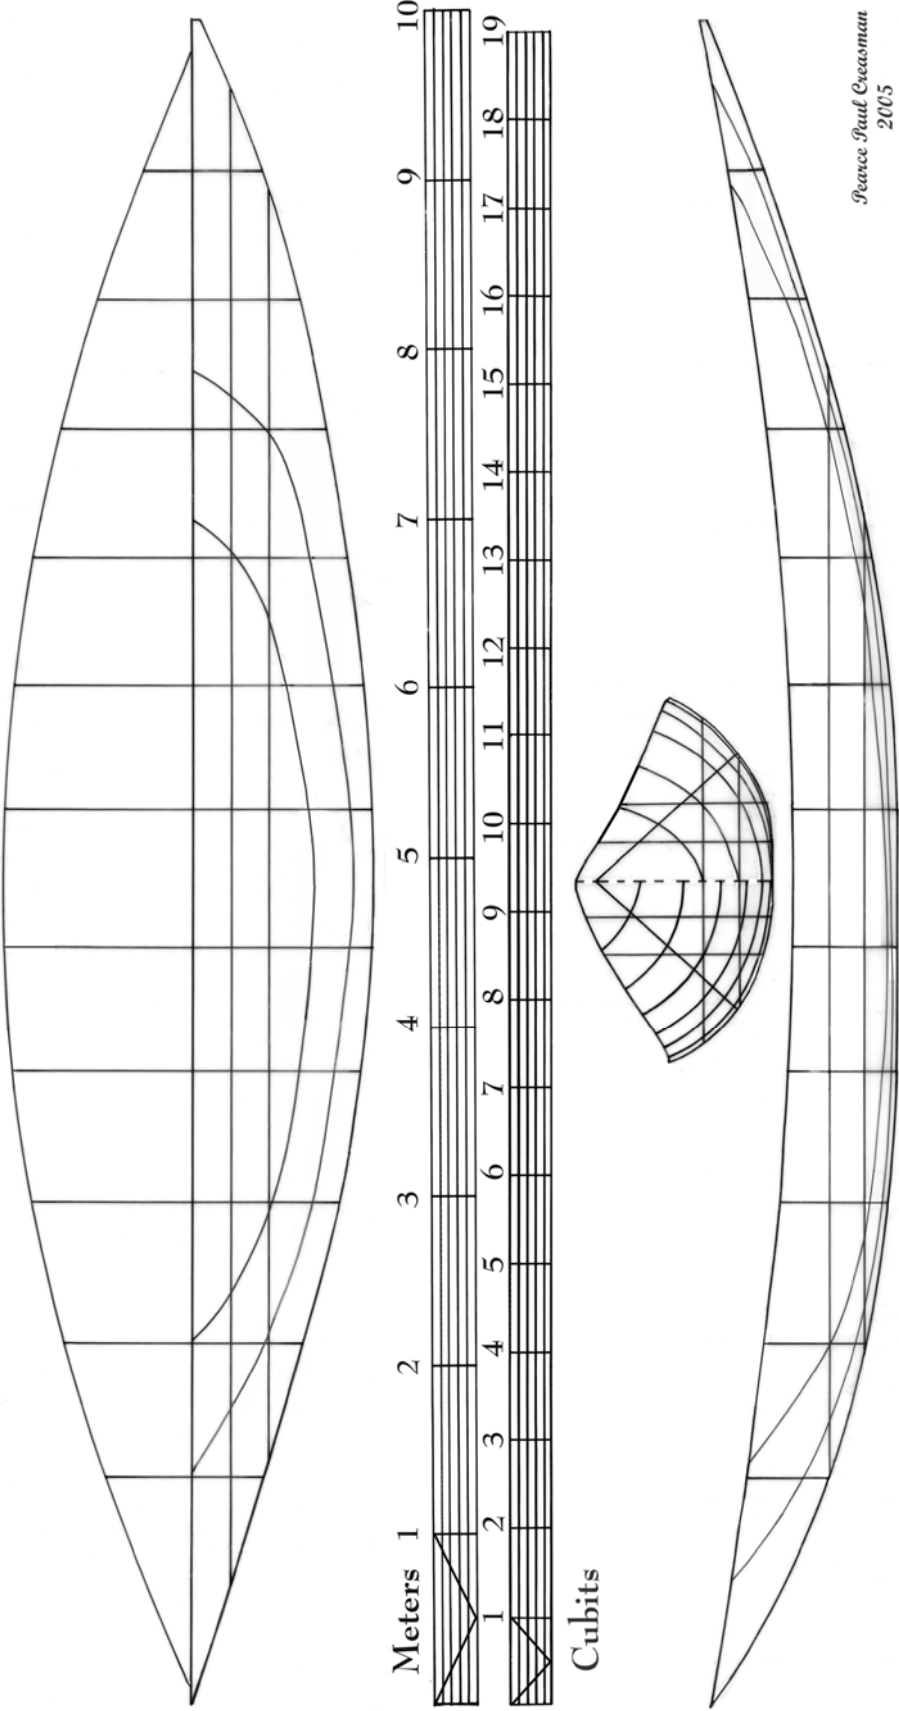
Figure 39. Hull lines for GC 4926.

The butt joints of each strake are approximately parallel with those of the same strake on the opposite side. Adjacent strakes do not have joints in line with one another. The planks above and below each butt joint exhibit their maximum widths at these locations, giving the hull planking an elongated honeycomb-like construction. The narrowest place on each plank is at its ends, or where a plank terminates its run into the center strake.

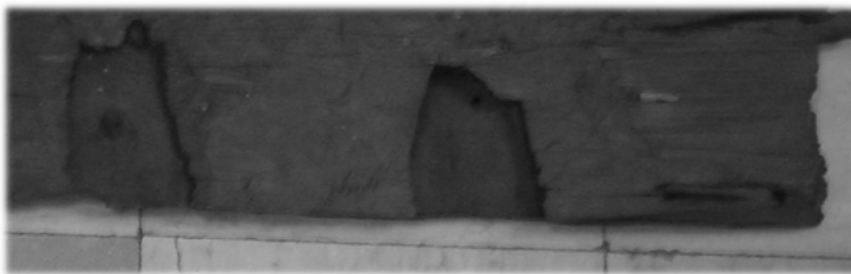
Figure 47. Exploded mortises from the underside of a deck plank - GC 4926 (P. Creasman).

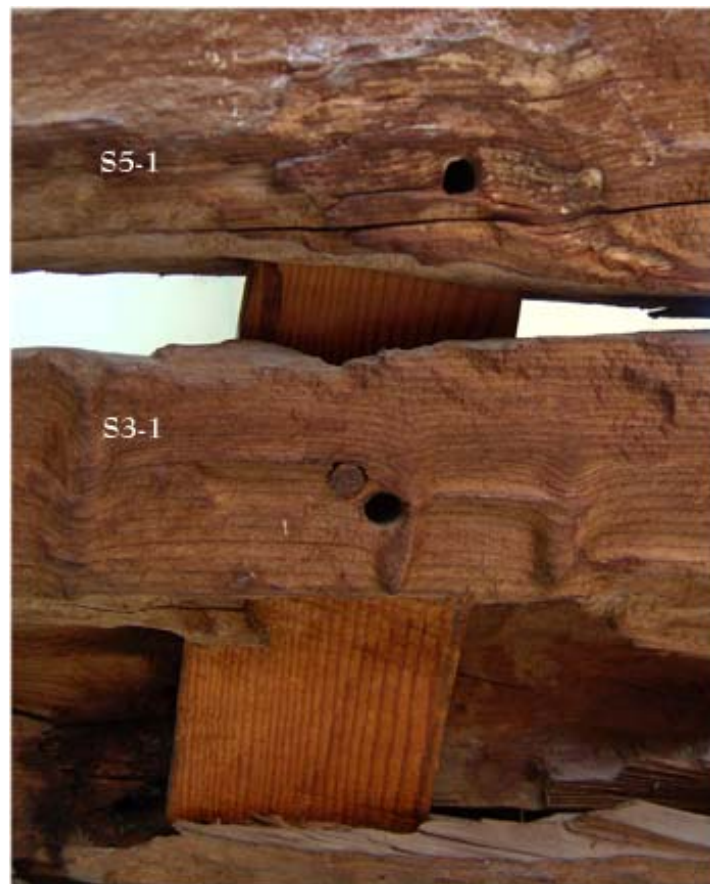
Figure 48. An ancient mortise with pegged modern tenon in GC 4926 (P. Creasman).

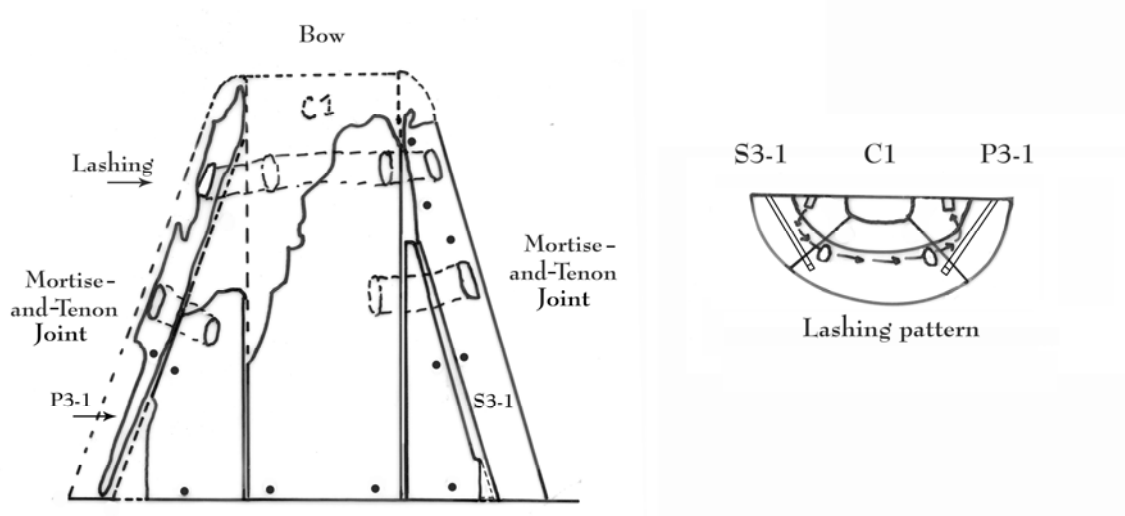
Figure 49. Lashing pattern at the bow of GC 4926 (P. Creasman).

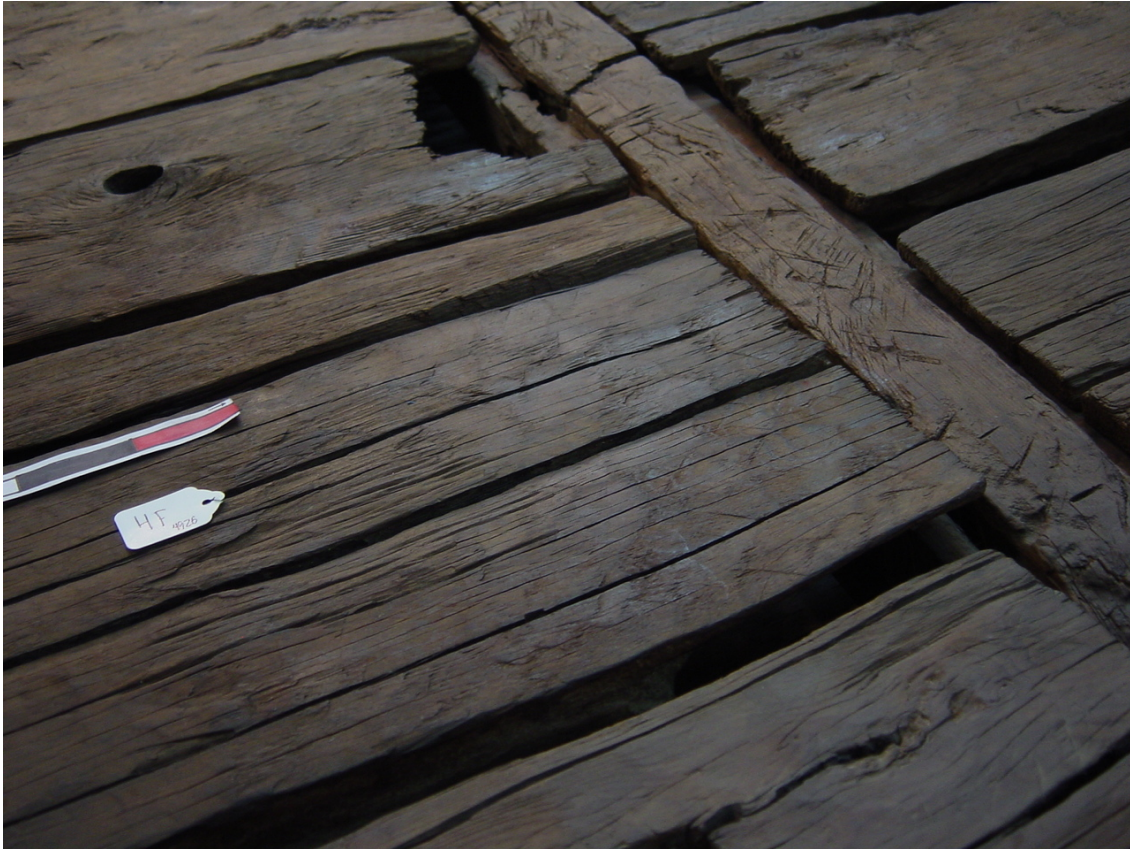
Figure 50. Tool marks on throughbeam 3 and deck planks in section 4 (room D) of GC 4926 (P. Creasman).

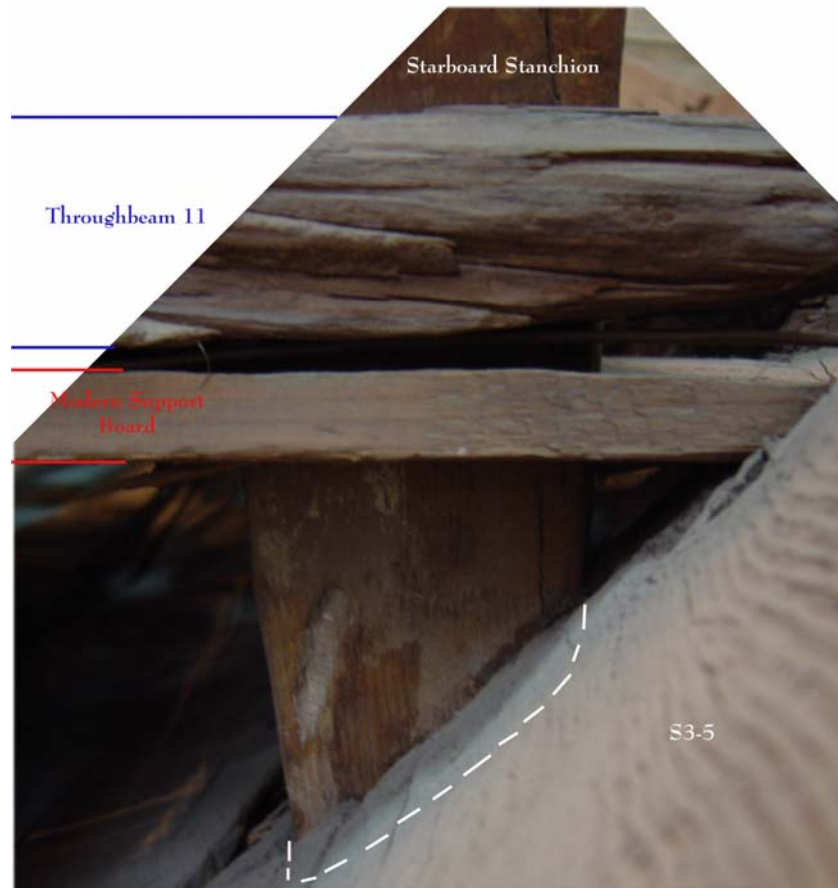
Figure 52. Starboard quarter rudder stanchion socket, GC 4926 (P. Creasman).

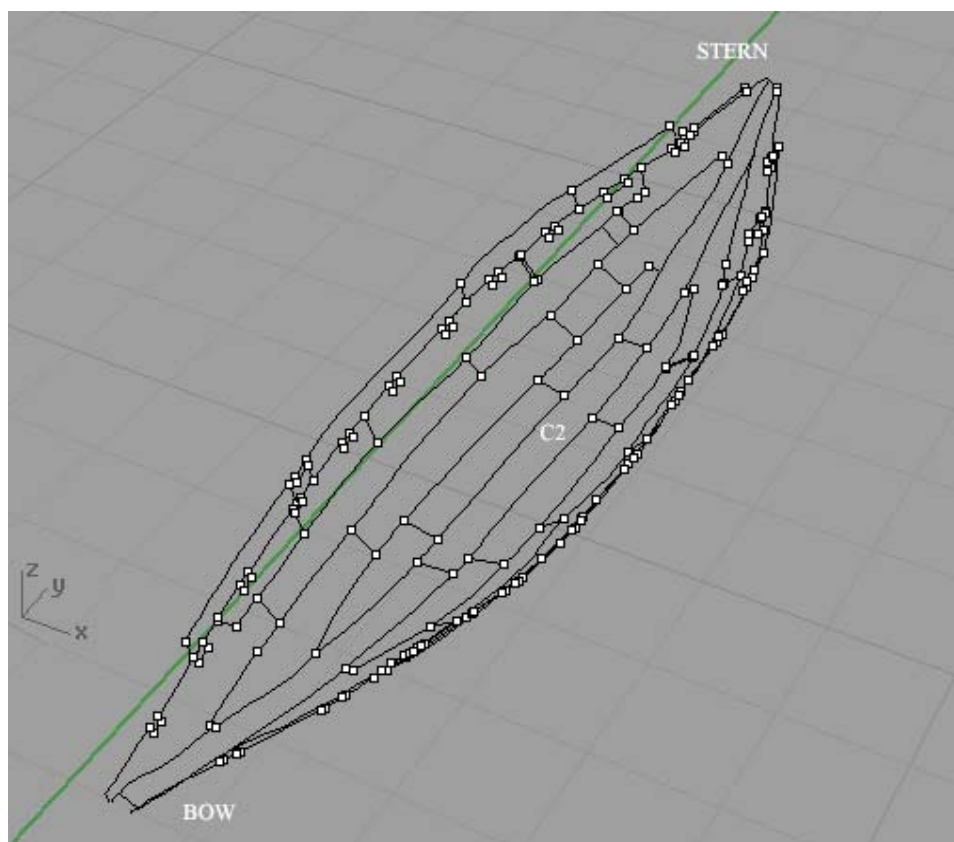
Figure 55. Three-dimensional rendition of the de Morgan boat (T. Larson).

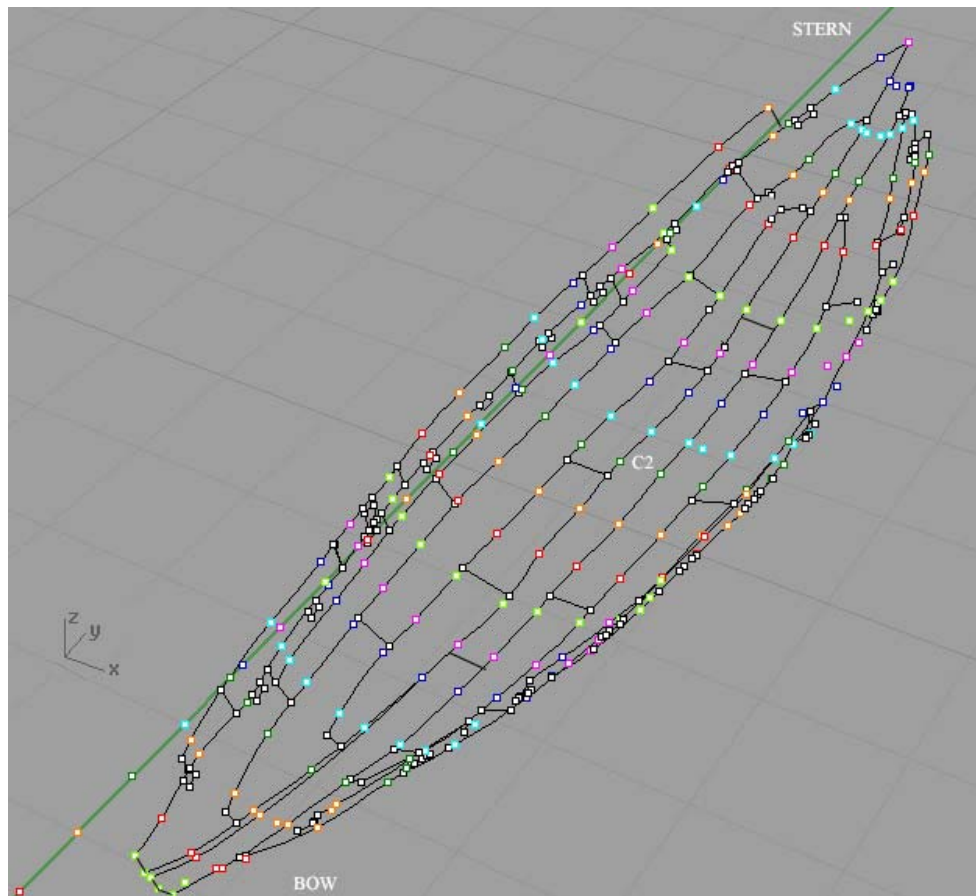
Figure 56. Three-dimensional rendition of GC 4926, with data points (T. Larson).

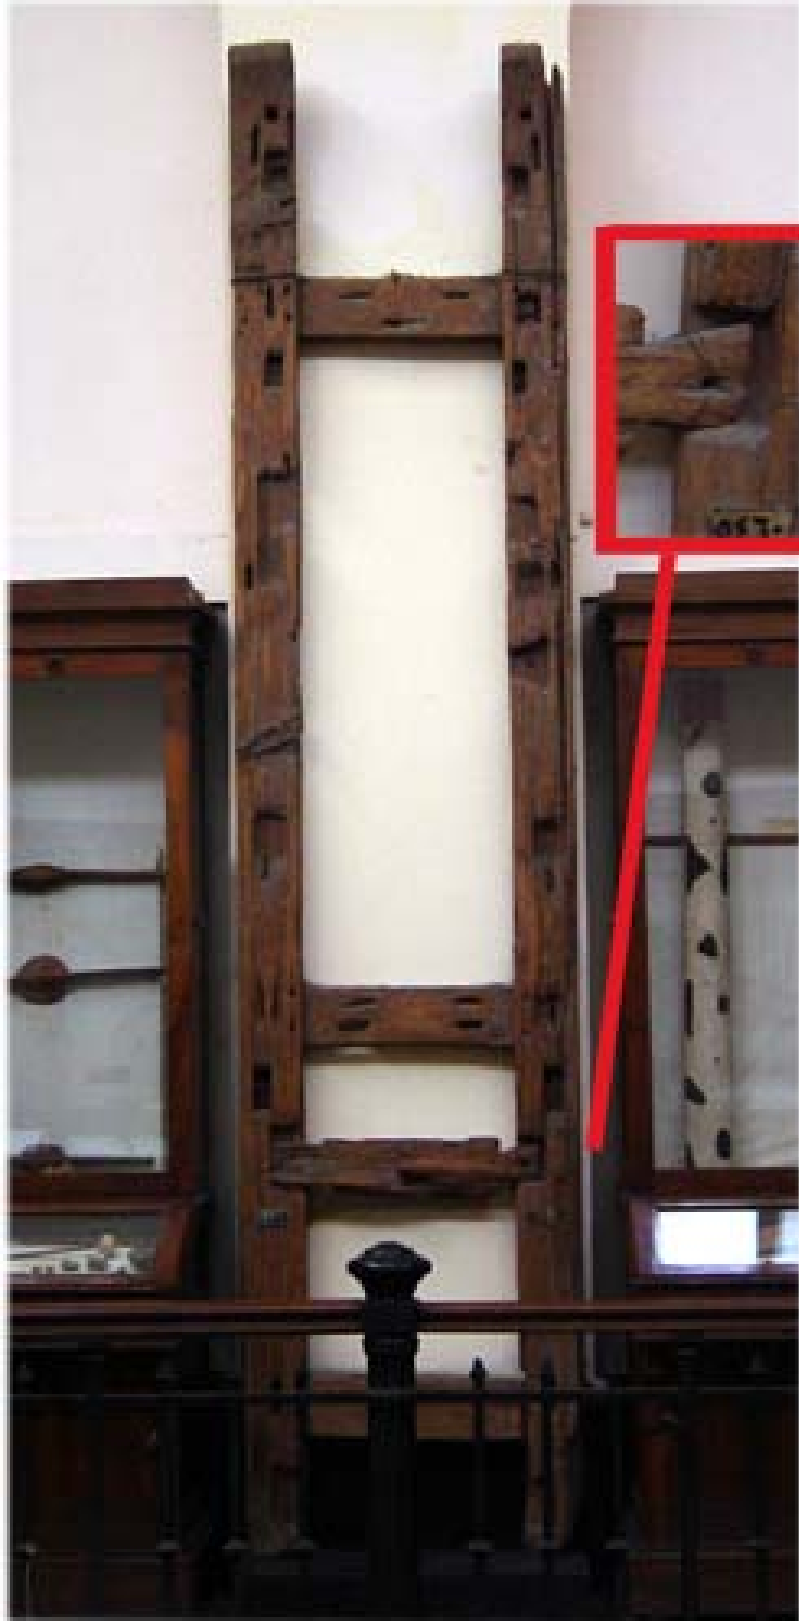
Figure 57. A sledge found with the Dahshur boats and close up of ancient dovetail joint (P. Creasman).
